A Review of Failure analysis found in Industrial Roller Chains

Krishnakumar. K, Arockia Selvakumar. A

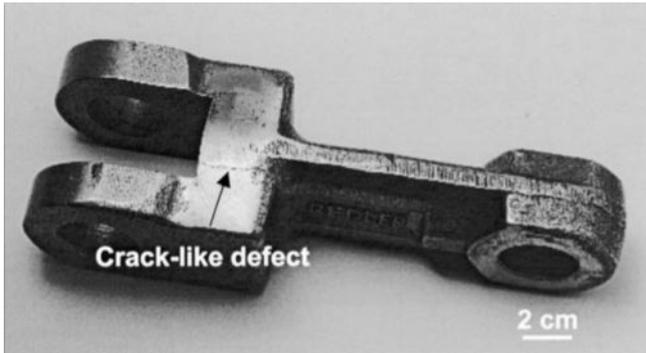
Sujata et al., (2006) have presented a case study that has a focus on failure of conveyor chain links. It is resolute that the failure was caused by defects related to the metal processing. These defects were known as surface defects in the billet which translate into a lap or fold-like defect in the final products. It is optional that the billet is to be properly dressed and the surface defects are removed prior to forging operations. Figure 1 illustrates the visual examination exposed to a shallow crack on the surface of the link.

Fig.1. Photograph viewing a crack-like surface defect on a finished chain link

The failure of engineering components due to presence of defects in the material is common. These defects or whichever is present in the material from the casting stage get developed during a heated environment in progress and thermal treatment operation. Classification of the origins of defects is an important undertaking while analyzing failures where pre-existing defects in the material are the causative factors. Systematic failure analysis can identify their origin and thereby corrective measures can be initiated to prevent the recurrence of similar defects in the final components. The chain links are forged parts made of 18MnCrB5 steel. The dealing out includes an upset forging from a bar stock followed by close die forging. The conveyor chain links have proved to be unsuccessful due to the presence of defects. The defects were known as forging laps or folds [1].

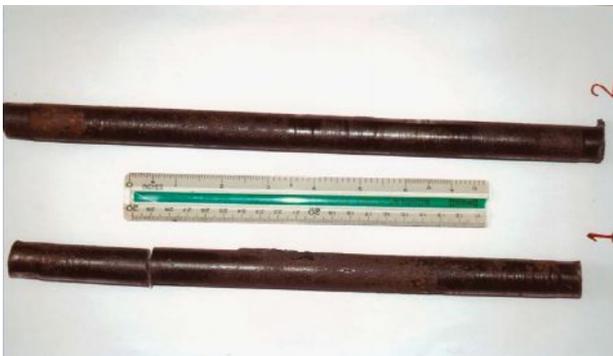
Fig. 2. Photograph of failed bearing pin 1 and pin 2. The fractured surface of the bearing pin 1 and pin 2 (lock end) is at the left of the figure.

From the results, it is found that the location of the fracture was near the end of the pins. Over here both the unsuccessful pins had been reduced to a cross section in the direct vicinity of the fractured surface. The chemical composition of the pin is definite to En-19 specifications. The hardness and metallographic studies indicate that the pins were induction-hardened at the exterior areas, whereas the core of the pins had tempered martensitic microstructure. The visual remarks of the failed pins establish an entrapment of fine to heavy coarse coal particles on the pin outside causing mild to severe polishing wear shown with following drop in the cross section. The metallographic studies show a non-equality in the induction hardening and unwanted coarse martensitic microstructure at the central part. The analysis of the fractured surface and fractographic study by SEM indicated fatigue fracture due to bending stresses and mild to reasonable torsion stresses. The proper induction hardening is shown to make a sure required case depth and use of En-24 steel for connecting pins that have been optional to further improve life of the connecting bearing pins [2].

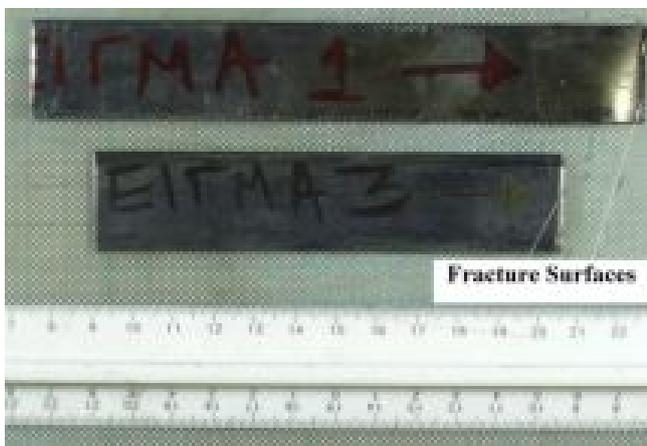
Fig.3. Macrograph of the failed stainless steel chain samples.

The failure analysis conclusions strongly suggest that the failure is caused by bending fatigue which is assisted by thermal cycling initiated from the strip plane and followed by ductile ending the overload fracture. The ending fracture which occurs via ductile failure (where the left over strip which is in a cross sectional area reaches a critical size) becomes incapable to sustain the operating load. The findings from the review of the service history (operating situations, e.g. process design, applied loads, thermal cycles), in arrangement to the examination of a potential substitution of the material to a extra heat (and fatigue) resistant one is recommended as further fatigue will only damage preventive actions [4].

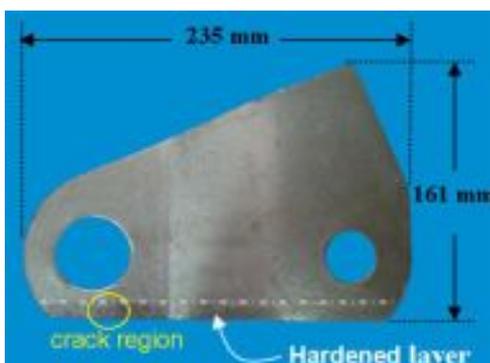
Fig.4. Photograph presents the chain link plate, indicating the crack region, the hardened layer location, and the main dimensions (thickness of 12 mm)

During the manufacturing process, this part is submitted to induction hardening, presently on one surface, before the galvanizing process. The incidence of surface cracks, during storage, disables the handling of these components. Chemical analysis and metallographic analysis, tensile, fracture toughness, and hardness tests, and fractography were conducted to classify and determine the causes of failure. The steel chemical composition was in unity with AISI 1045. The metallographic analyses and fractography did not display the presence of zinc into the cracks; this is a signal that the cracks occurred after the galvanizing method. Tensile and fracture toughness test results are as projected. The crack exterior and the fracture toughness sample surfaces showed two dissimilar fractured micro mechanisms: dimples and intergranular. The deferred fracture related with the predominance of intergranular fracture micro mechanism at the induction hardened layer and the high hardness point is a clear signal of the hydrogen embrittlement [5].

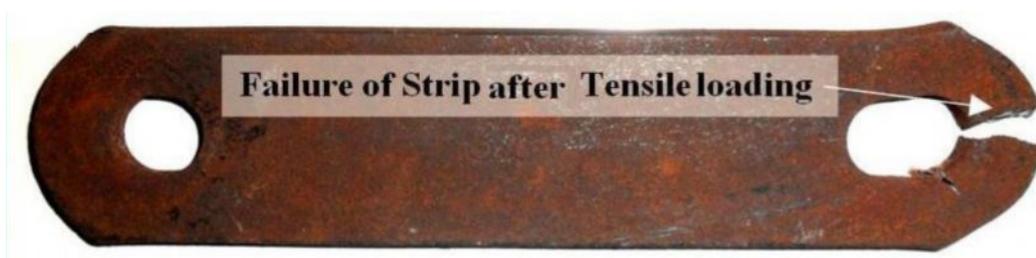
Fig.5. Failure of Chain Plate

From Figure 5, the outer side plates are primarily tension members, and they also are subjected to considerable bending and stress concentrations in and around the region of holes. The outer side plates necessitate sufficient strength to survive the tensile forces lacking deforming or breaking, which result in having sufficient ductility to withstand considerable bending and to resist fatigue [7].

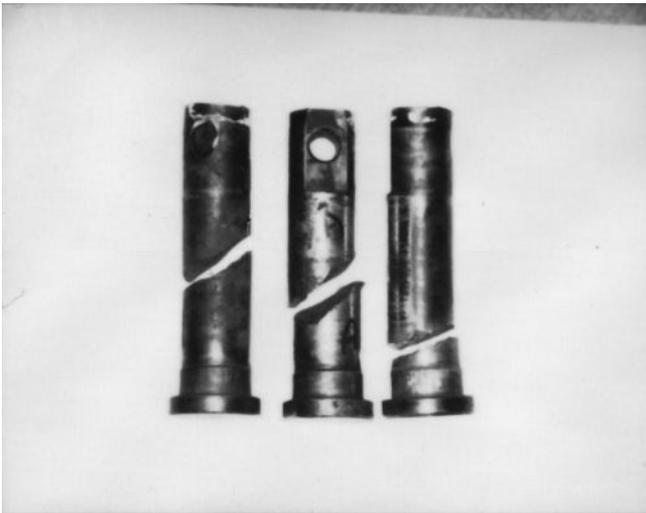
Fig.6. Three fractured bearing pins showing the position and angle of the fractures

The bearing pins had been heat-treated so that they had become susceptible to hydrogen embrittlement, and had cracked. The source of hydrogen was qualified to corrosion of other steel components in the machine system. In organization to minimize the probability of future failures, it was suggested that the source of the corroded parts be identified. In addition, it was suggested that the authors should liaise with the industry work environment in order to suggest a suitable heat treatment schedule for future bearing pins [8].
