Improvement of the Interlaminar Shear Strength on Surface Modified Glass Fibre/Stainless Steel Wire Mesh Reinforced Hybrid Composites

Abstract : This paper investigates the interlaminar shear behavior of surface modified glass fiber/ stainless steel wire mesh reinforced epoxy hybrid composites. The glass fiber is treated either by 1N solution of sulfuric acid or sodium hydroxide. The stainless steel wire mesh is also surface treated by either electro dissolution or sand blasting. The hybrid composites are fabricated using epoxy resin reinforced with glass fiber and fine stainless steel wire mesh by hand lay up method. The hybrid composite consisting of acid treated glass fiber and electro dissolved or sand blasted stainless steel wire mesh exhibits superior interlaminar shear property in comparison with the composites made without any surface treatment. The fine modifications identified on the surface texture of the glass fiber and stainless steel wire mesh enhances the bonding between the resin and reinforcement which improves the interlaminar shear strength.

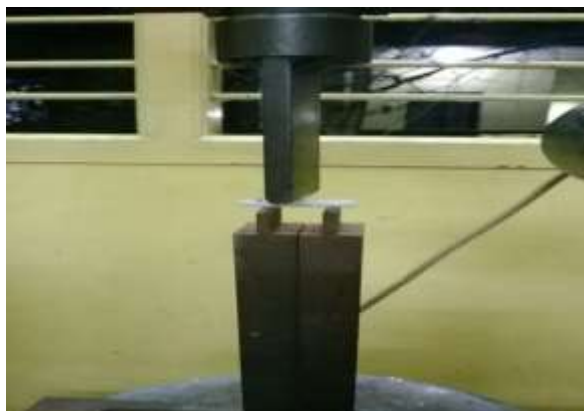
**Fig -2** Photograph of Inter-laminar shear test (ILSS) specimen mounted on UTM.

A short beam test was used to determine the inter-laminar shear strength of the non-hybrid and hybrid polymer composites. The inter-laminar shear test measures the bond strength between the various layers in a laminate. The Inter-laminar shear test was conducted using 5 Ton capacity UTM (FIE make India). Small specimens of nominal size 25 X 5 X 3 mm were used. The inter-laminar shear test was conducted at a crosshead speed of 1 mm/min. The distance between the anvil is 11 mm. These specimens were tested according to ASTM D2344-84. The inter-laminar shear strength(I) was calculated by using the formula

where P is load to fracture (N), b is the width (mm) and t is the thickness (mm). Three specimens of each laminate were tested and the mean value of the three tests were tabulated. The photograph of ILSS specimen mounted on UTM shown in Fig-2.

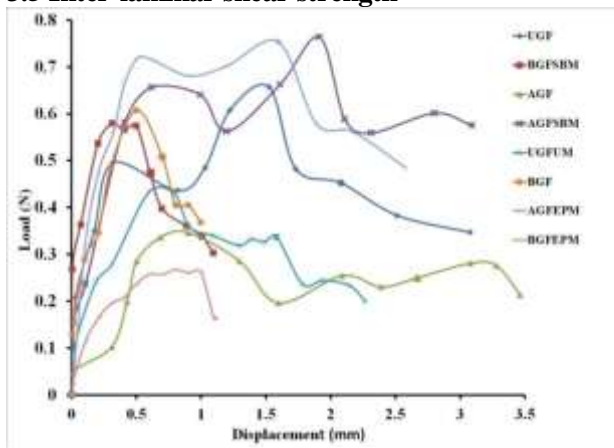
Fig -7 Inter-laminar shear strength values of composite laminates.

A typical load displacement diagram for both hybrid and non-hybrid laminate are shown in Fig-7. The response of each hybrid and non-hybrid laminate shows nearly linearity for the elastic limit in the initial loading stage. This trend is continuous until to reach an apparent elastic limit. After this point the curve showed a decreasing load. The AGFEDM, AGFSBM, UGF composite laminate showed a significant decrease in load just beyond the peak load. The AGFEDM hybrid laminate achieved the highest peak load among all the hybrid and non-hybrid laminate. The UGF non-hybrid laminate reached a peak load slightly less than the hybrid ones. For hybrid laminate AGFEDM laminate exhibits an interlaminar shear strength of 32MPa and BGFEDM exhibits interlaminar shear strength of 15MPa. Non-hybrid laminate UGF exhibits ILSS value of 26MPa and AGF exhibits 14 MPa.

It could be stated that presence of irregular corrosive pits enhance interlaminar shear strength. Surface modification of glass fiber by acid and stainless steel wire mesh by either electro dissolution treatment or sand blasting could result in improvement of bonding strength. From Fig-7 it was observed that the interlaminar shear strength value of AGFEDM, AGFSBM was 128% and 114% higher than AGF laminate. BGFSBM was 64% higher than AGF but less by 7% of BGFEDM.

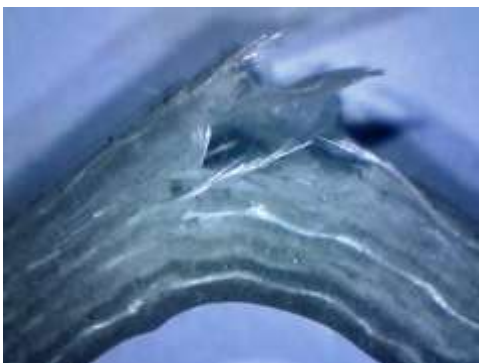
Fig-8c Microscopic image of AGF laminate

In AGF shows the typical bottom layer delamination due to high elongation and tensile stress. This laminate shows resistance to delamination for five layers from top. The bottom layer subjected to tensile stress showed not only fiber elongation the resin also showed good elongation.

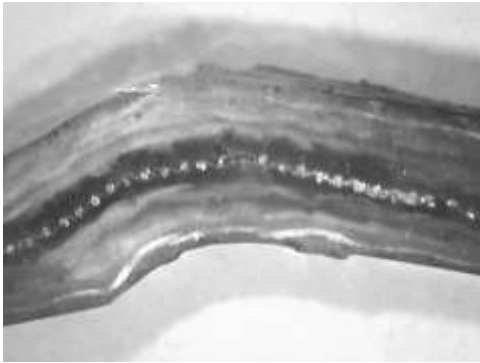
Fig-8d Microscopic image of AGFSBM laminate

In AGFSBM shows better bonding between seven layers of acid treated glass fiber and sand blasted steel wire mesh. The complete resistance to delamination can be observed. Some transverse tensile cracks are identified only at the bottom layer of the laminate due to high tensile stress. The remaining layers showed good resistance to delamination.

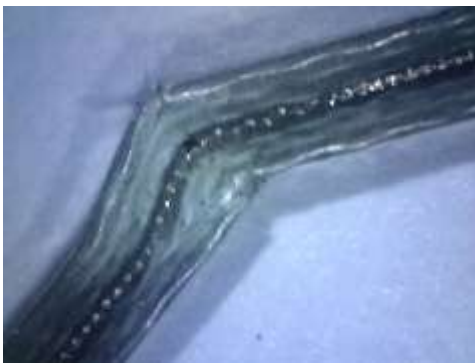
Fig-8e Microscopic image of UGFUM laminate

In UGFUM shows the good resistance to delamination for all seven layers of the laminate. Transverse compressive cracks were identified at the top layer and the transverse tensile cracks identified at the bottom layer of the laminate. No delamination was identified above and below the neutral layer of the laminate. It produces the inter laminar shear strength value of 17MPa.

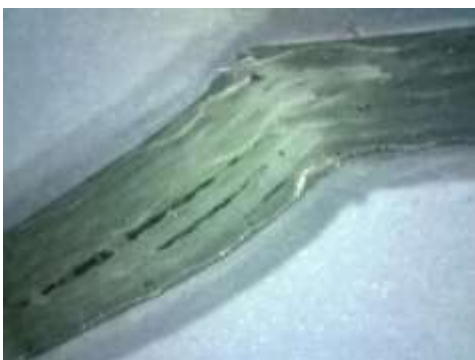
Fig-8f Microscopic image of BGF laminate

BGF shows the delamination above and below the neutral layer of the laminate. This is because of alkaline treatment of the glass fiber. Beneath the loading nose no cracks were identified. Transverse tensile cracks are identified at the bottom most layer of the laminate. It produces the ILSS value of 24MPa.

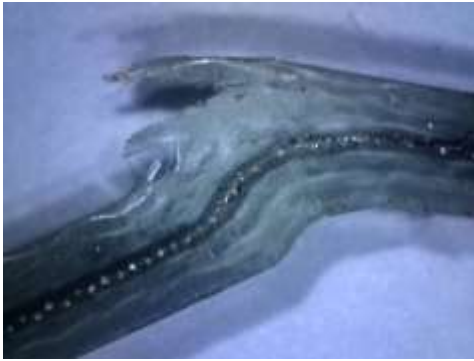
Fig-8g Microscopic image of AGFEPM laminate

In AGFEDM shows good resistance to delamination of the laminate. Transverse tensile cracks are identified bottom most layer of the laminate due to high tensile stress and elongation induced on the glass fiber. Better bonding was identified between acid treated glass fiber and electro dissolved stainless steel wire mesh. It produces ILSS value of 32MPa.
