## Repair of Corroded Reinforced Concrete Beams using Glass Fibre Sheets and Cementitious Composites

P. Bhuvaneshwari\* and K. SaravanaRajaMohan

School of Civil Engineering, SASTRA University, Thanjavur, India,

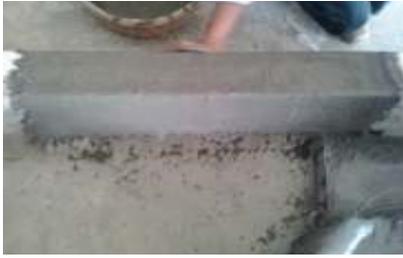
**Fig.2 Wrapping of beams using glass fiber sheet and cementitious binder**

Group B4 used epoxy as binder. The proportion followed for resin and hardener was 100:35 by weight and mixed continuously for 5 minutes to have uniform colour. Using sand paper the surface was made uniform before wrapping. Beams in all groups were wrapped with glass fiber sheet as shown in Fig.2. Glass sheet was stopped at a depth of 75mm from top to avoid direct loading.

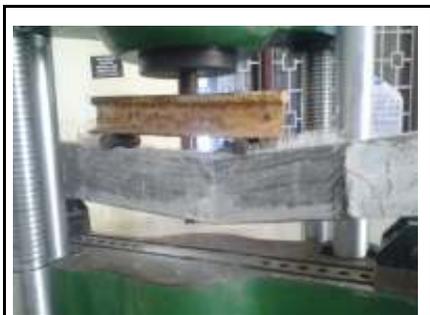
**a) Strengthened beam with glass fiber sheet and epoxy binders**

**Fig.3 Flexure test on beams**

Repaired and cured beams were tested under two point bending in the universal testing machine of 1000KN capacity as shown in Fig 3. This load case was adopted to have uniform moment without shears between the loads. Steel plates were used to distribute the load for entire width of the beam. Deflectometers were used to measure the deflection at midpoint and below the pointof loading.

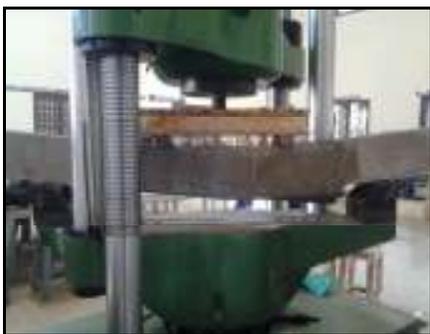
**b) Strengthened beam with glass fiber sheet and cement composite binders**
