Influence of the concentration of tin in the plating tank. Defects and behavior towards the corrosion of tin

Ali Kissoum^{1,3}, Abdenabi Abidi^{2*}, Mohamed Labaiz³,
Omar Assala³ and Nouredine Gherraf⁴

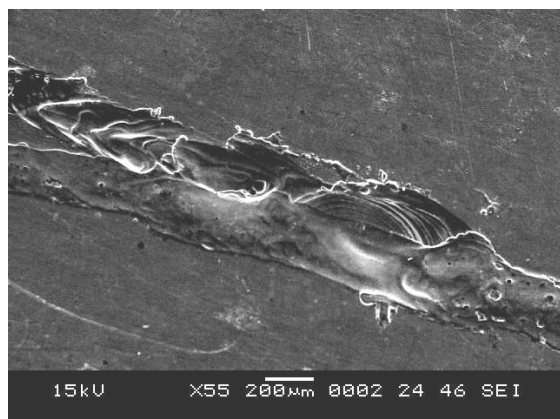
Figure3a Side 1–Stripe of non-uniform melted porosity in non-uniform melted tin

The SEM photos indicate that defect was likely the result of an electrical arc that caused the tin to melt and splatter. The SEM photos (figures3a and 3b) of the stripe also indicate that it may have been caused by premature tin melting. The stripe has the appearance of a weld bead. Cross-sections (figures 4a and 4b) through the stripe in two locations did not reveal a steel defect. Build up on the re-flow conductor rolls is the likely cause of these defects.

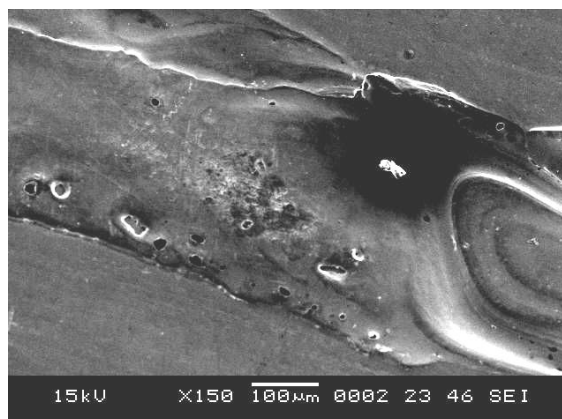
Figure3b Side 1 – Close up of stripe showing tin
